Charles River Watershed Association

The Charles River Natural Valley Storage Area (NVSA) Health Assessment

Understanding our Vital and Threatened Wetlands in the Charles River Watershed

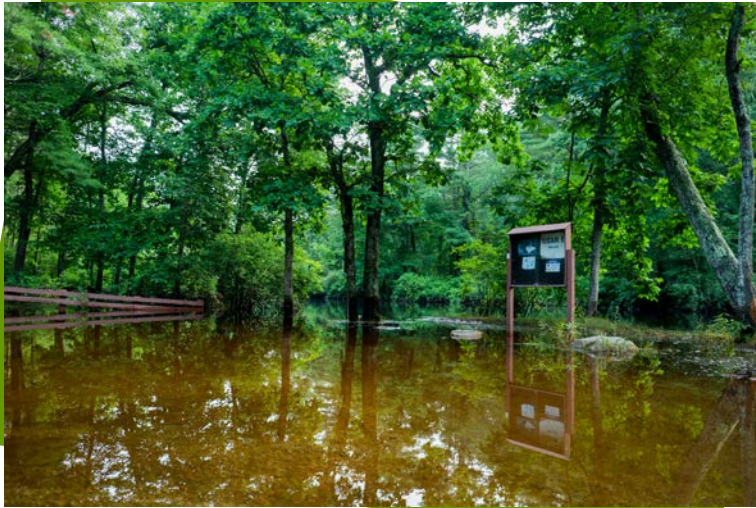
NVSA Flooded in July 2021

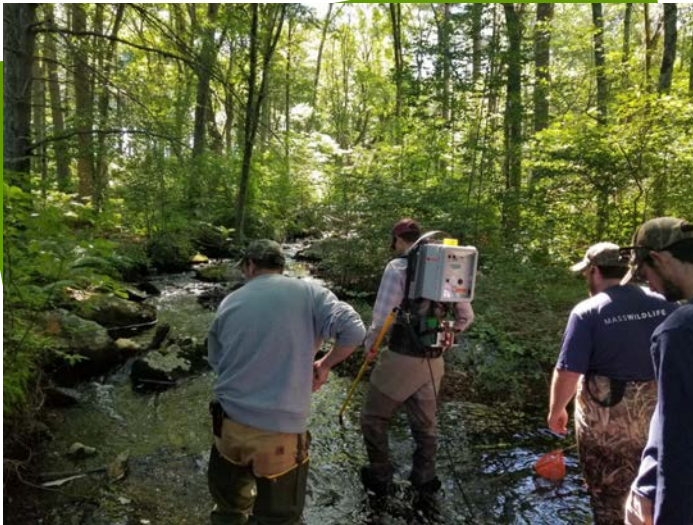
Electrofishing in Dix Brook

Upstream of the culvert only four fish were found, all redfin pickerel between 2 and 3 inches long. Downstream of the culvert, there were both larger redfin pickerel and sunfish. Based on these observations, Mass Wildlife speculated that the culvert underneath Financial Park may be considered 'perched', meaning that only smaller fish can pass through it to pass upstream. These results suggest that Dix Brook has low biodiversity and restricted fish passage.

- Work with the Town of Franklin to address the perched culvert at Dix Brook
- Advocate for continued land conservation and/or low-impact development
- Consult with land conservation groups to address encroachment from development on a watershed scale
- Engage volunteers in removal of invasive plants, including bittersweet vines

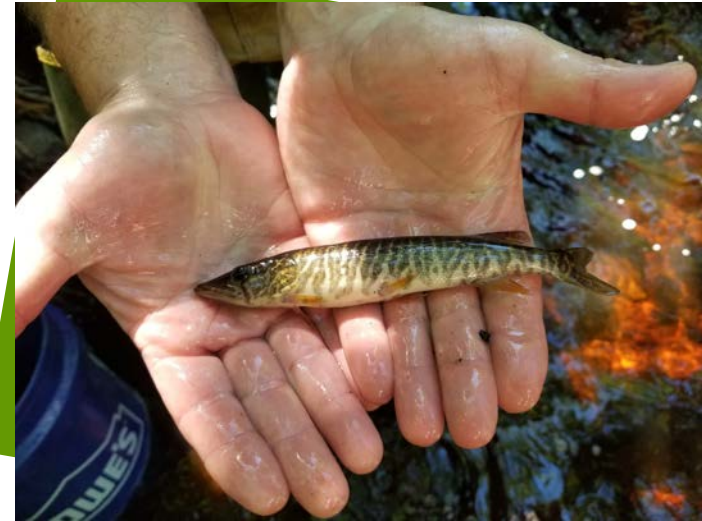
Redfin Pickerel

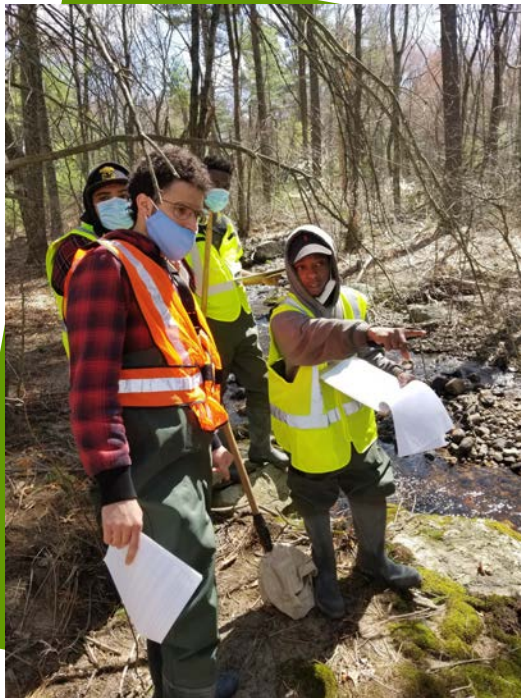
CRWA and volunteers also assessed stream health by surveying Dix Brook's features to determine aquatic habitat quality. Using EPA's Habitat Rapid Bioassessment Protocols, three habitat assessments were completed on separate dates in 2020 and 2021. Overall, Dix Brook had a 'Suboptimal' habitat, scoring 67% of the maximum possible habitat score.

**CRWA Volunteers
Performing a
Habitat Assessment**

Results show that Dix Brook is a fairly unaltered stream habitat buffered by a variety of healthy forested wetland plants. However, the stream suffers from bank erosion and has too much sediment deposited on its bed, reducing the habitat quality and the long-term stability of the stream channel.

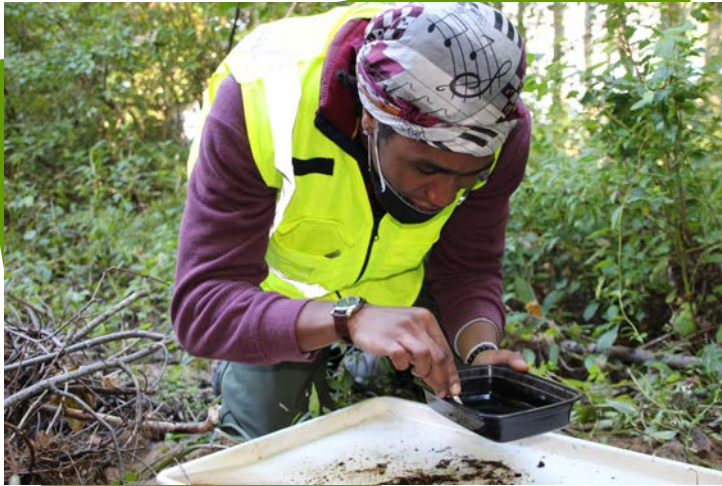
CRWA Volunteer Sampling River Bugs

CRWA and volunteers sampled benthic macroinvertebrates in Dix Brook twice in 2021. Once collected, bugs were identified and water quality was scored based on EPA's Rapid Bioassessment protocol with the scale: Poor (<20), Fair (20-40), Good (>40). Some of the bugs found included midge larvae, stonefly nymphs, mayfly nymphs, caddisfly larvae, aquatic worms, and scuds, which represent a range of pollution sensitive and pollution tolerant species. The average score for the two samples had a water quality score of 17.8, indicating poor water quality conditions overall.

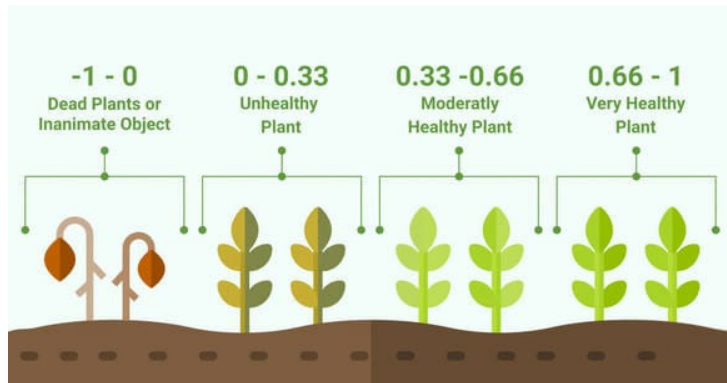
Diagram showing NDVI values as they relate to vegetative health. On maps, red indicates dead plants or inanimate objects and dark green indicates very healthy plants.

To assess the vegetative health of Area N, aerial imagery collected from a drone and from satellite images was used. The Normalized Difference Vegetation Index (NDVI) was calculated for each image using mapping software. In images, healthy plants reflect near-infrared light as part of photosynthesis, which is used as a measure of vegetation health.

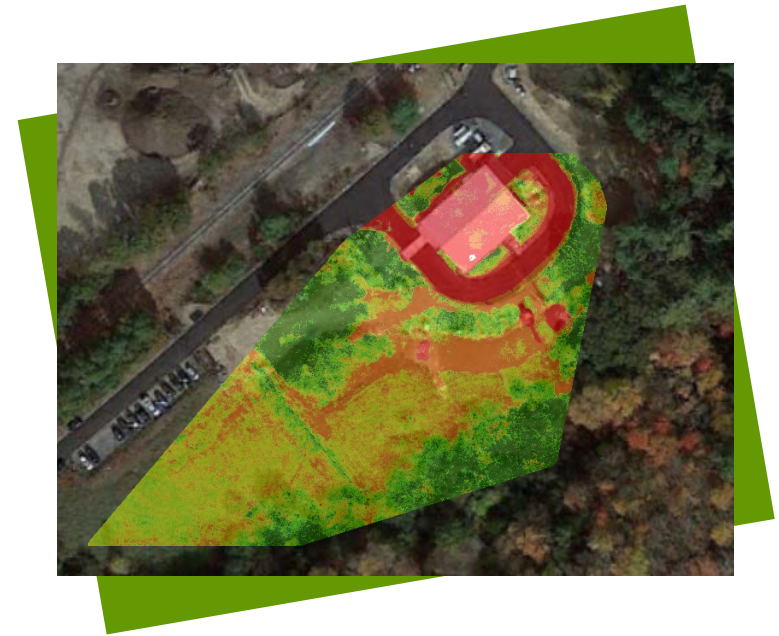
A 5 acre portion of Area N with NDVI calculated from drone images.

A drone survey was conducted over part of Area N during summer 2021, and satellite images were collected over the area from different time periods. After trial and error, CRWA found that using satellite images to calculate NDVI was favorable over using drone imagery, as it was not able to cover a large enough area with enough resolution to evaluate the >100 acre NVSA conservation areas. In addition, images have been taken regularly with Landsat satellites regularly since the 1980s, allowing evaluation of trends in vegetative health over time.

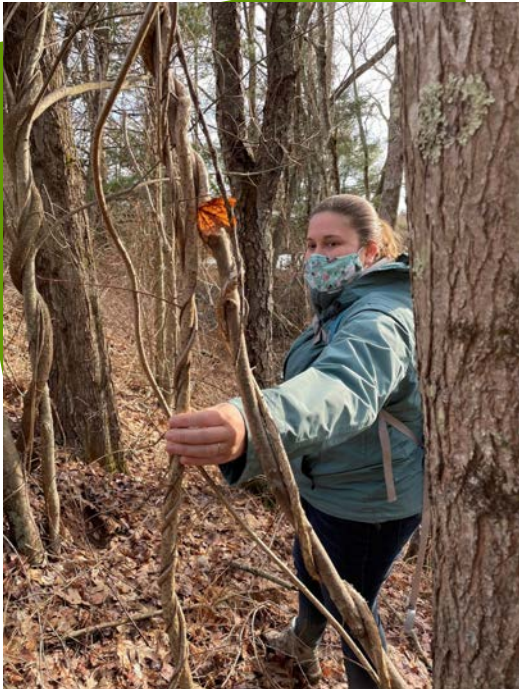
**Bittersweet Vines
in Area N**

Invasive plant species observed during field surveys of NVSA Area N included bittersweet, multiflora rose, and garlic mustard. Bittersweet vines were observed taking over the canopies of fully grown native trees, especially on the edges of the conservation areas. As trees and wetland plants clean and store floodwaters, a decline in the health of native vegetation is likely beginning to decrease the flood reduction function of the NVSA wetlands.

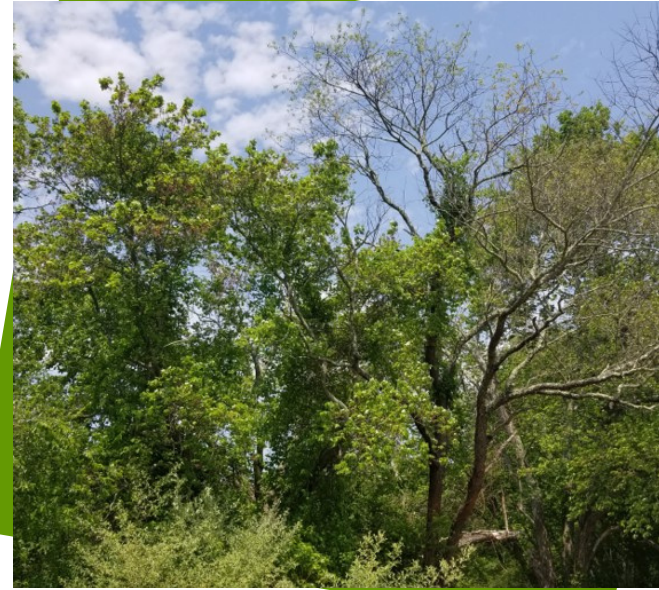
Another major threat to vegetative health in the NVSA wooded wetlands is the introduction of invasive plant species. Invasive species are fast-growing non-native plants that quickly dominate ecosystems, killing native plants and reducing biodiversity. Bittersweet is an invasive vine that is particularly rampant in New England forests and wetlands. Over only months bittersweet can cover, shade, and outcompete other vegetation in the area, and can even uproot full-grown trees when left unchecked.

Dead Tree with Bittersweet Vines
